Significant Events on the Pipeline Right of Way – Our Stakeholders Are Raising the Bar

Bathtub Curve Analysis

Wendy Wagster
Director Operations, Safety & Integrity, INGAA

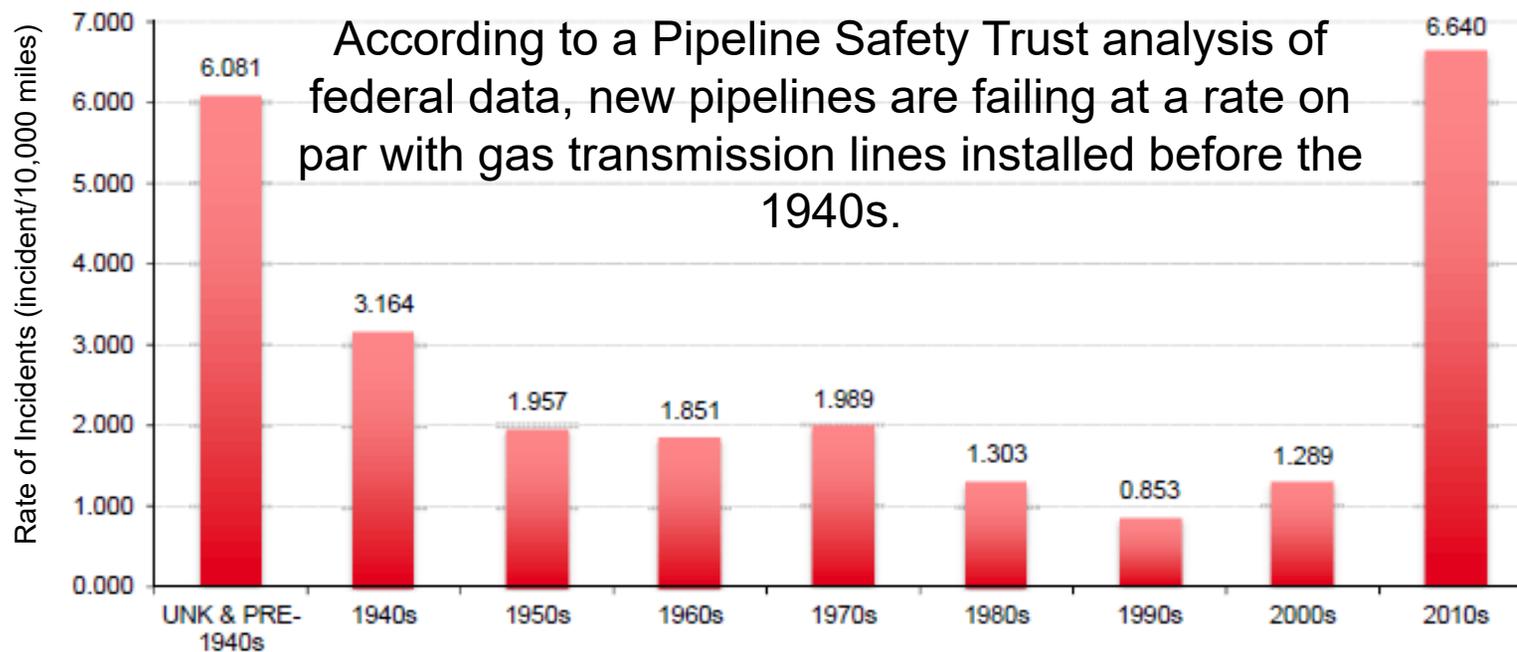
Average number of annual incidents from 2005 through 2013 per 10,000 miles of onshore gas transmission pipe (by decade of pipe installation)

As of March 2015.
Sources: U.S. Pipeline and Hazardous Materials Safety Administration, Pipeline Safety Trust

As the U.S. rushes to build gas pipelines, the failure rate of new pipes has spiked.

- Pipeline Safety Trust used the PHMSA incident report that was published in March of 2015
- They filtered the data to include:
 - Onshore Pipelines
 - Transmission systems
- PST correlated the number of incidents to the mileage of pipe installed (per decade) from the PHMSA annual report

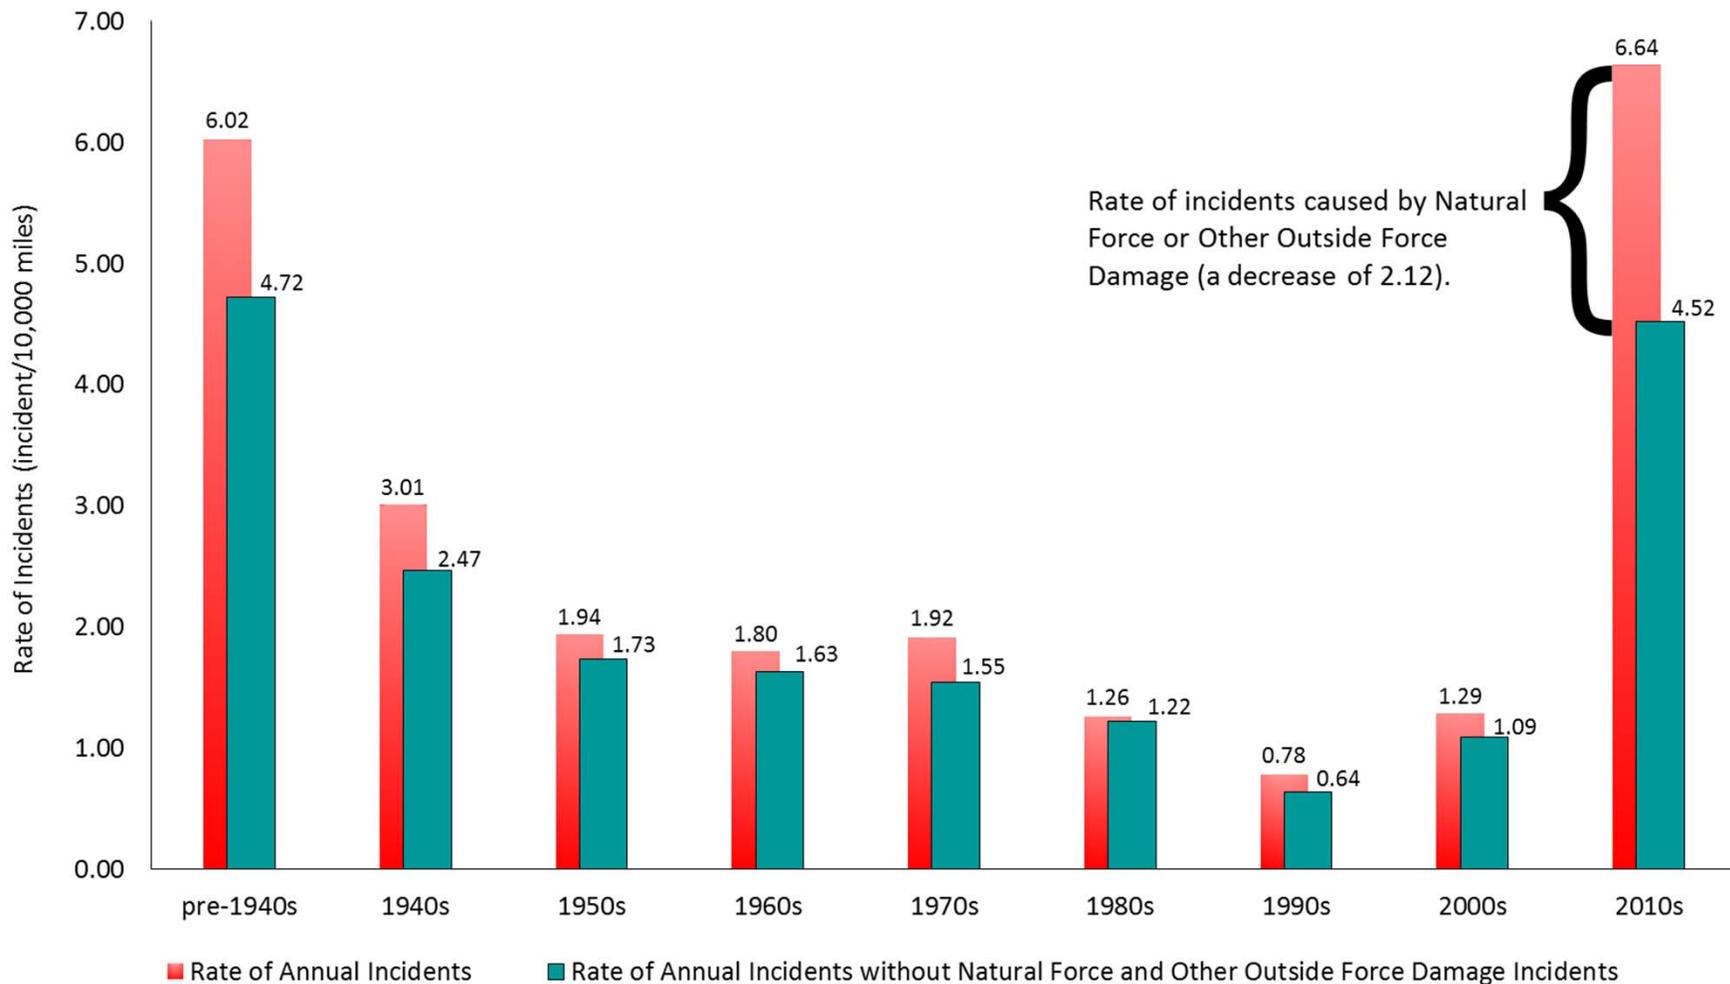
Average number of annual incidents from 2005 through 2013 per 10,000 miles of onshore gas transmission pipe (by decade of pipe installation)

- Natural Force: one incident reported in 2011
 - Earth settlement caused stress on a one-inch power gas line. The one-inch line broke at a fitting. The gas that was released ignited because of a near by generator.

- Other Outside Force: one incident reported in 2010 and one in 2012
 - A water line adjacent to a natural gas pipeline had a small pin hole leak. The water spraying through the pin hole water blasted the natural gas pipeline and caused a leak.
 - A rock was pinned to the underside of the pipe and caused a dent with a crack. This pipe was installed in 1959 and has been reclassified to proper decade.

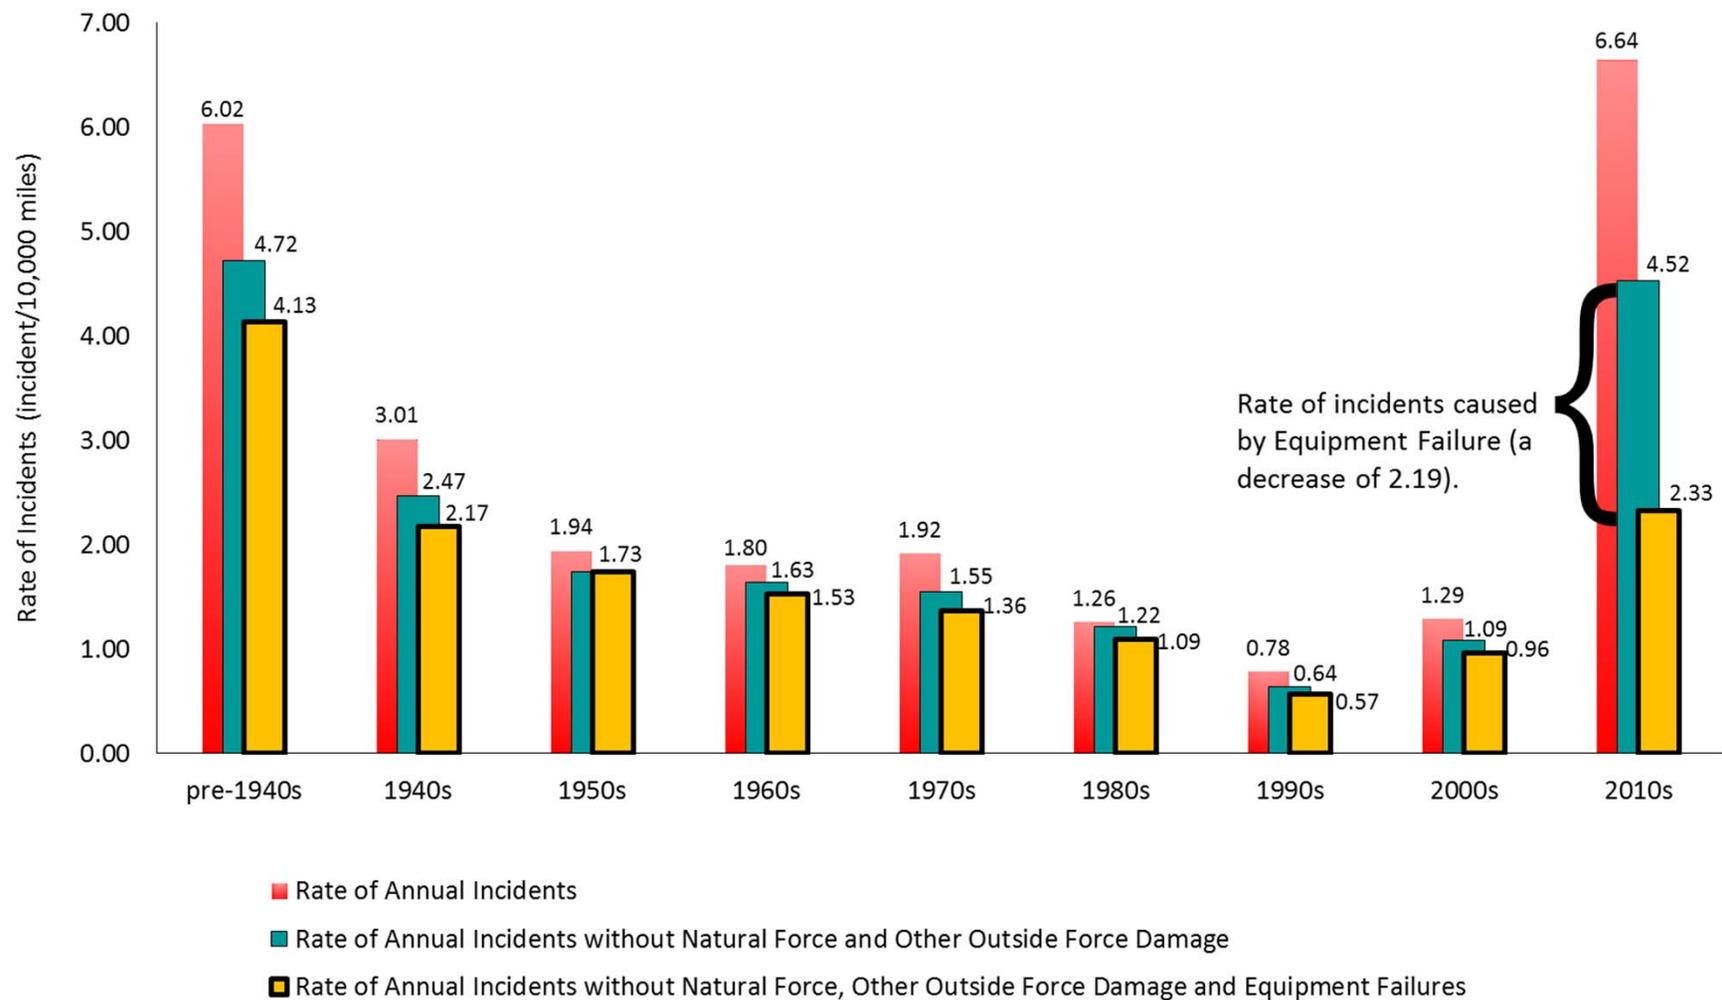
Average number of annual incidents from 2005 through 2013 per 10,000 miles of onshore gas transmission pipe (by decade of pipe installation)

- Equipment Failures: four incidents reported
 - While installing a pig bar assembly, the hot tap machine experienced a failure. The section of pipe had to be blown down and a conventional fitting was installed.
 - A bolt on sleeve was used to repair a defect. The bolt on sleeve began leaking and had to be removed. The section of pipe with the defect was replaced with new pipe.
 - The sensing line froze on a pilot-operated relief valve which caused the relief valve to open and vent gas. The amount of gas released was greater than 3,000 Mcf.
 - During the installation of 16-inch hot tap, on a 30-inch mainline, the tapping machine became lodged in the 16-inch hot tap valve.
